TOLERANCES	PART NO.	ITEM	DESCRIPTION	MAT.	FIN.
FRACTIONS 1/2	TITLE: CIRCUIT DIAGRAM HQ-110 RECEIVER				
DECIMALS 1/10	MATERIAL: _____				
ANGLES 1/2	DRAWN: _____				
UNLESS OTHERWISE SPECIFIED	FINISH: _____				
SCALE	HARRISLABORATORY NEW YORK				
	NO. 38998				
	T

# POSSIBLE RECEIVER TROUBLES & SUGGESTIONS.com

## SUMMARY OF FIELD COMPLAINT WITH SUGGESTED PROCEDURE FOR ELIMINATING THE TROUBLE

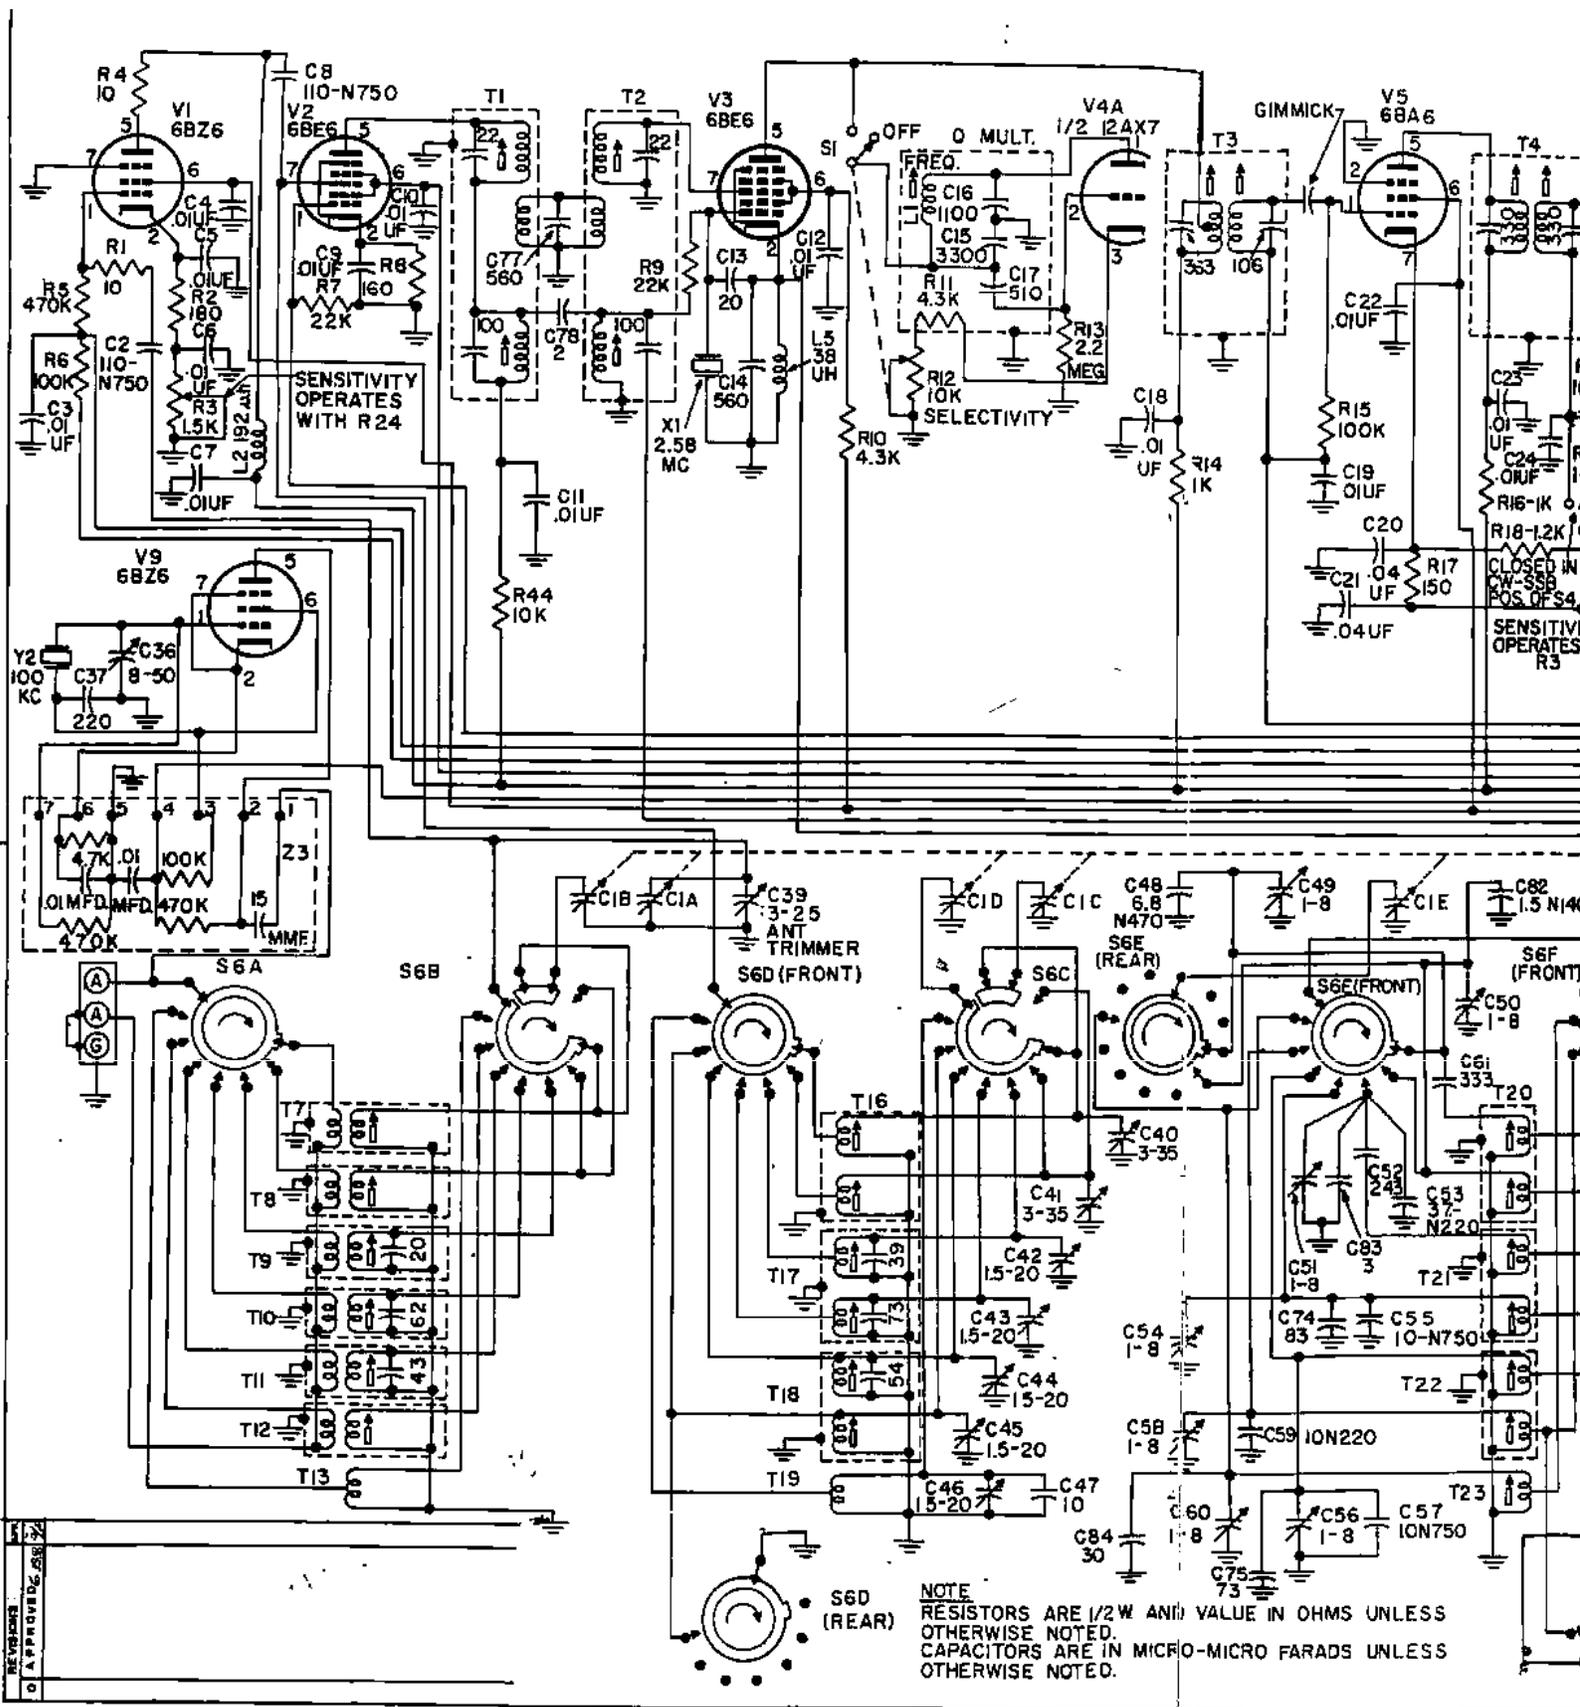
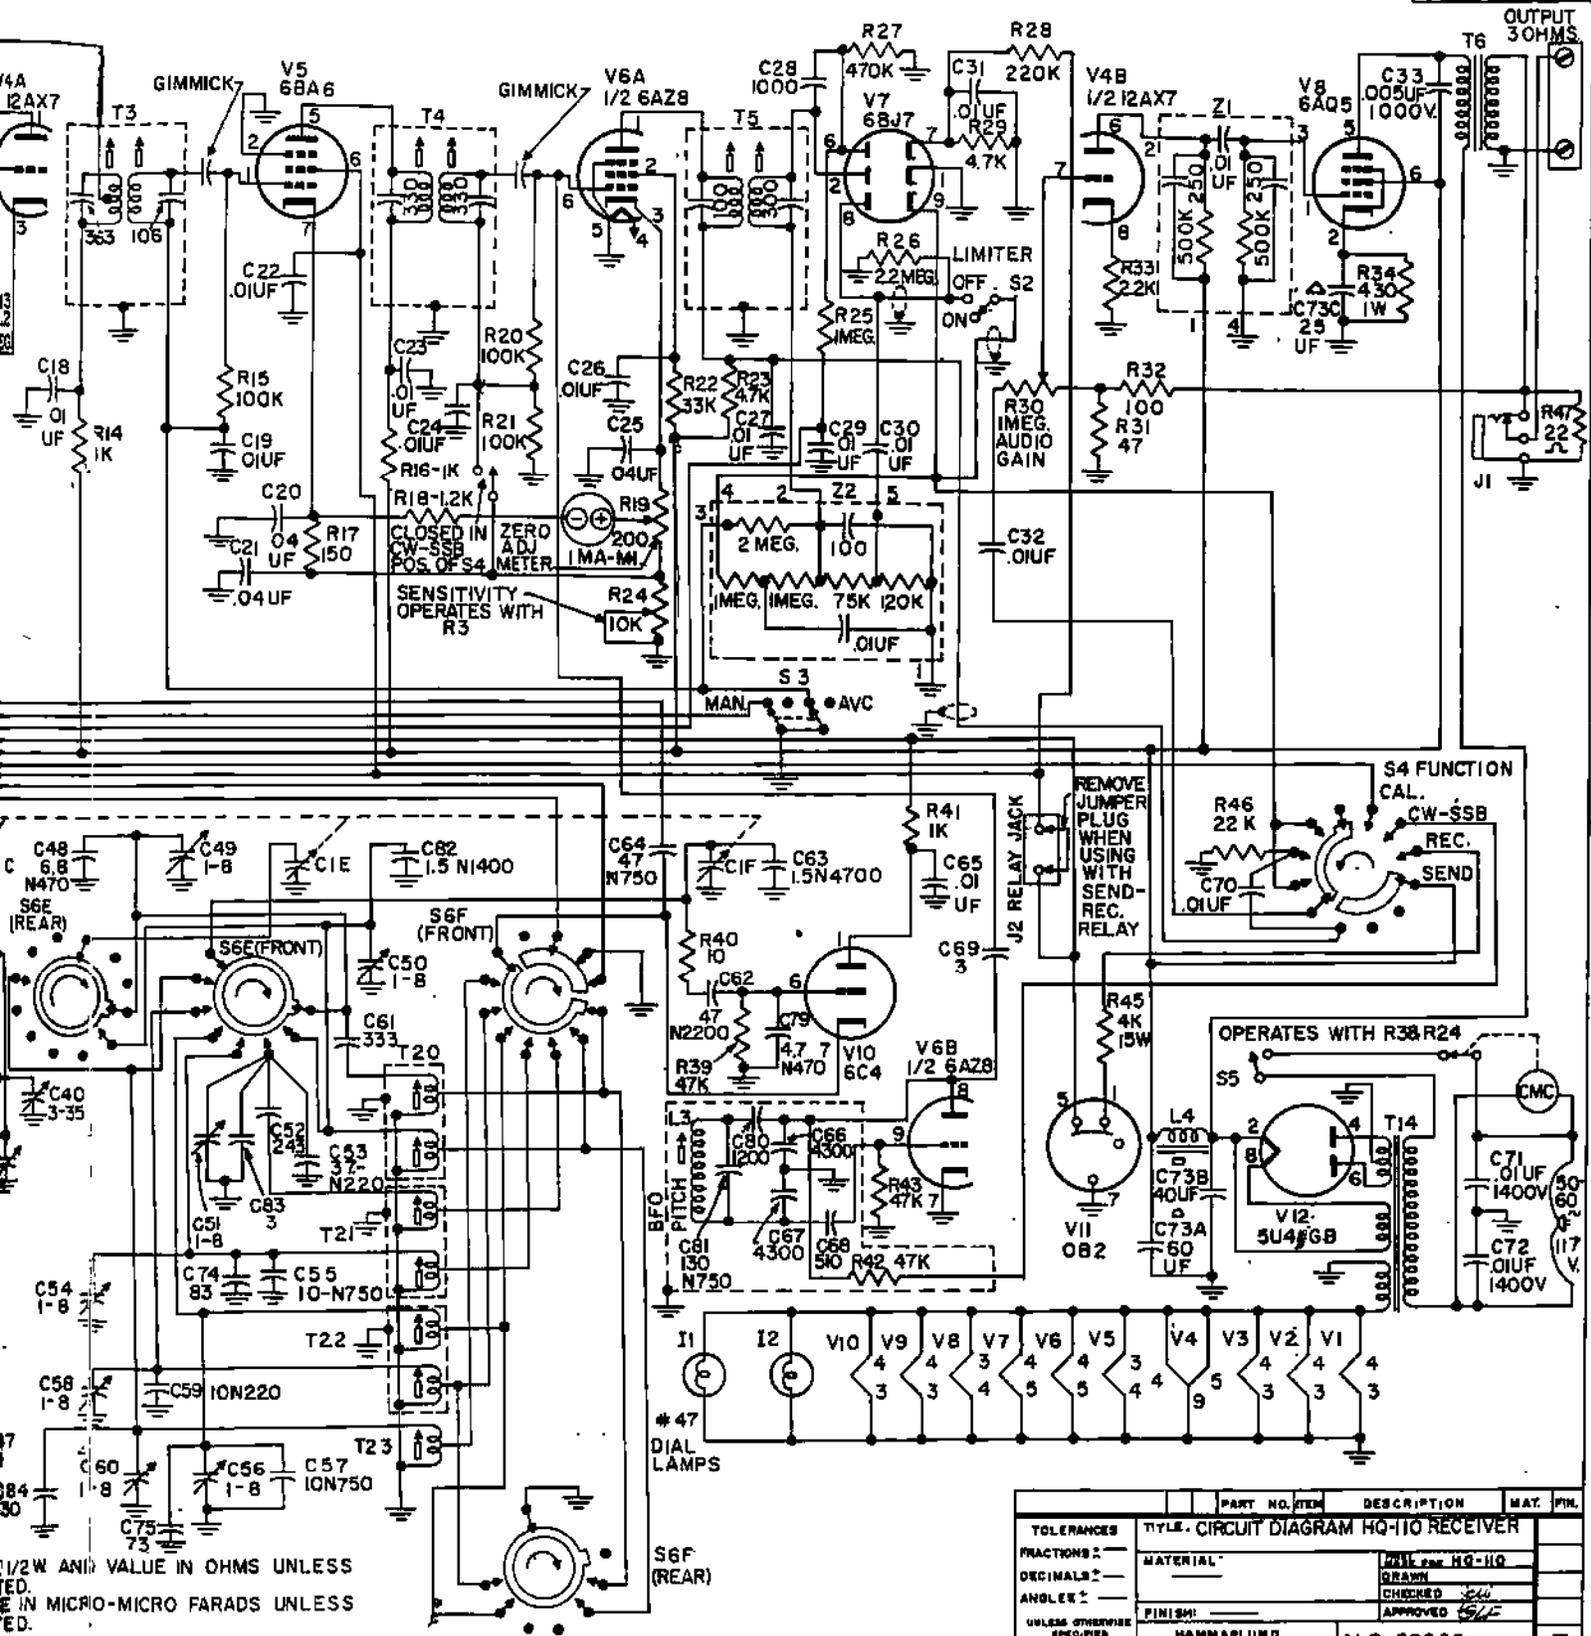
1. Most of the trouble that has developed in the field has been due entirely to one or more defective tubes. In the event your receiver has excessive hum or erratic "S" meter operation, the two tubes most likely to cause this condition is V-7 in the schematic diagram on Page 19 of our Instruction Manual. This is a 6BJ7. V6A or the 6AZ8 tube type has also developed internal shorts.

2. Failure of the "Q" multiplier to operate properly or another possible source of excessive hum may be due entirely to the 12AX7, V4A and V4B, since this is a combined "Q" multiplier tube and first audio amplifier. Please do not rely too much on testing the tubes in a tube tester for unless they are internally shorting, there is a possibility that a tube tester will not prove reliable. This is due to the fact that most tube testers do not provide a means of testing excessive heater to cathode leakage, which is the most common cause of hum complaints. It is, therefore, suggested that any suspicious tube be replaced with a new one, since this is by far the best method of definitely eliminating this possible cause of complaint.

3. Excessive oscillator drift which would be most noticeable on all of the high frequency bands plus a microphonic condition is usually the result of a poor type 6C4 high frequency oscillator or V-10 in the schematic diagram. This tube is also capable of producing a poor beat note that may have a ripple in it, especially noticeable on the high frequency bands.

4. Excessive drift can also be attributed to a poor 6BE6 employed in position V2. In addition, the 6BE6 employed in V2 can also cause hum modulation which will be most noticeable on the two high frequency bands. Sometimes merely interchanging the 2 6BE6 tubes employed in Positions V2 and V3 may produce a noticeable improvement. If this is not the case, we would suggest the purchase of another 6BE6.
