# Heathkit Troubleshooting Tips

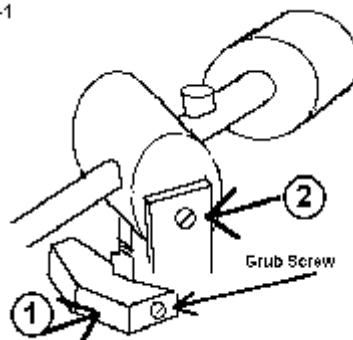
Figure AD-1

- **Tone-arm won't clear raising pad, cuing lever operation jerky (see Figure AD-1):** At first appearance, it's the rising pad (location 1), however, check the pivot screw (2) to make sure it isn't too tight (this also has some effect on tone arm setdown).

- **Tone-arm behaves normally halfway across LP, then sticks--playing the same groove over and over. Manually moving the tone arm inward about 1/2" fixes:** This is due to grossly misadjusted anti-skate

adjustment, causing the antiskating spring to latch on to one or more protuberances.

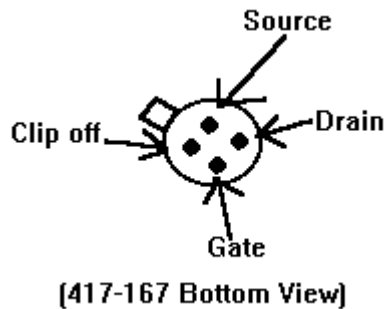
**E-band dead on low end:** (A) Replace Q301 with 417-167 (see above). (B) Change R304 to 1500 ohms. (C) Change R303 to 2200 ohms. (D) Swap L303 w/2200 ohms (prevents FMing when switching to "C" band).

- **E and F bands dead on the low end:** This may be due to a low gain-bandwidth product of Q301, so that with the lower Q of C305-L305-R303 (on E) and C306, L306, R304 (on F) when tuned to their respective low ends prevents enough positive feedback to maintain oscillation. To cure, try removing R303 and replacing the 2200 ohm at R304 with a 5600 ohm resistor. If this doesn't work, try the unauthorized modification shown with the illustration, above.

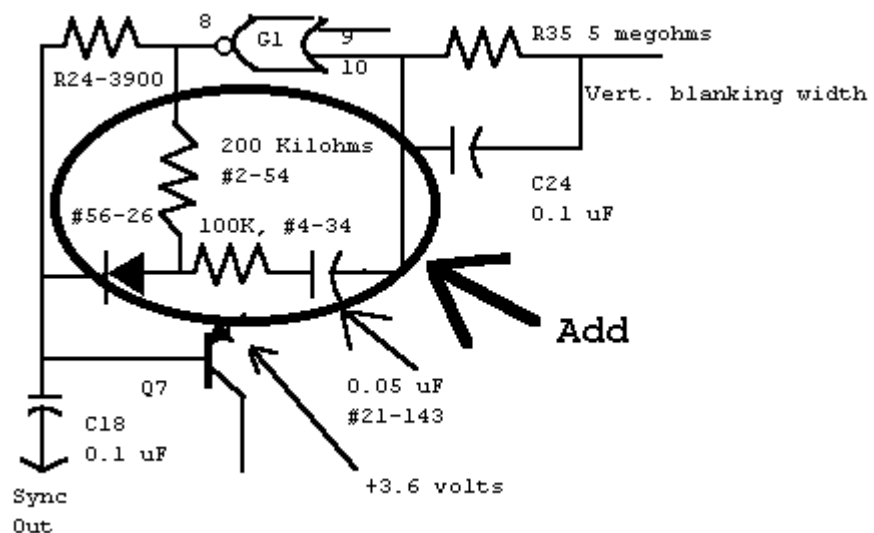
- **Excessive bend in vertical lines at top of screen with signal being injected through tuner--present mods don't help:** Install the following change:
