ANTI-TVI MODIFICATION FOR THE T-4XB

DRAKE TR-4 TVI PROBLEM SOLVED

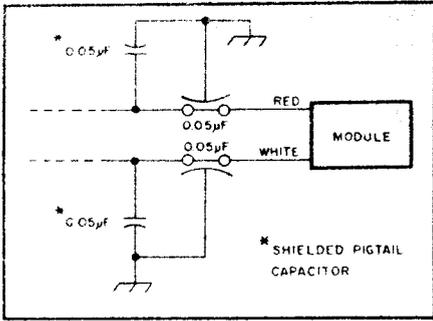
Fig. 13 — When rf from a 130-watt mobile transmitter upset the ignition system in a 1980 Ford police car, Morris Hall, N4MH, installed bypass capacitors as shown in this drawing. The remedy effectively eliminated the problem.

Since I took these corrective measures, the RFI no longer affects the ignition when the transmitter is being operated. — *Morris E. Hall, N4MH*

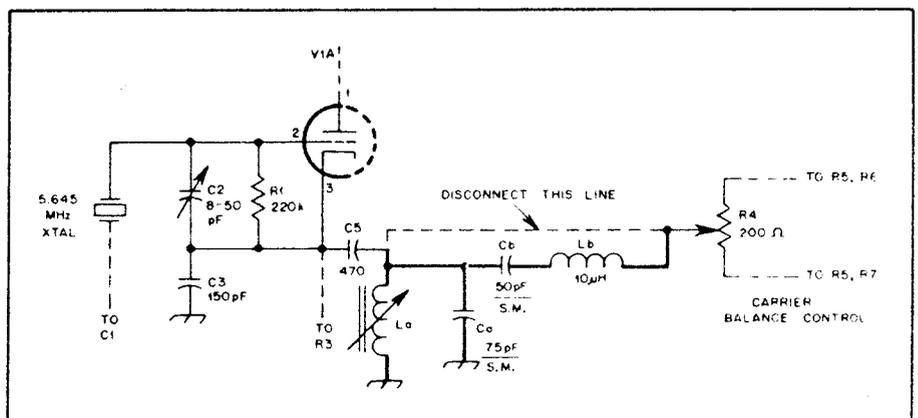
In the Hints and Kinks section of June 1979 *QST*, J. H. Mehaffey described a TVI problem with his TR-4 very similar to one that had plagued me for some time. I have a Drake T-4XB. His simple and successful modification of the TR-4 to clear up the harmonic output of the 9-MHz carrier oscillator clearly pointed the way for me.

Unlike the TR-4 with a 9-MHz oscillator, the T-4XB carrier oscillator is at 5.645 MHz, so different values of components are required to make the fix. In my case, those used were "junk box" values, ones at hand close enough to what seemed to be needed. Fig. 14 is drawn in a manner to match that of the Drake manual.

Fig. 14 — The W6HB anti-TVI modification for the Drake T-4XB. Heavy lines show added circuitry.

There is sufficient chassis room for the few required parts under and around R4, the carrier-balance potentiometer of the T-4XB. L_a , the slug-tuned coil, is easily mounted in the extra hole of the left-rear chassis apron. With the adjustment screw on the outside, access to it is easy, although this is a seldom-needed tuning adjustment. L_b and the two capacitors are supported by a small double tiepoint and the respective leads. The short ground connections are made to the socket frame of V1.

I also took Mr. Mehaffey's suggestion regarding linearizing the final by disconnecting C53 and C58, the 470-pF cathode bypass capacitors of the 6JB6 output tubes. L_a can be peaked with a dip meter. Touch-up tuning for maximum drive, as shown by increased final-amplifier plate current, should follow. To complete the adjustment, realignment of the carrier oscillator ought to be carried out using the procedure in the Drake manual.

TUNE L_a TO 5.645 MHz + RETUNE OSCILLATOR.

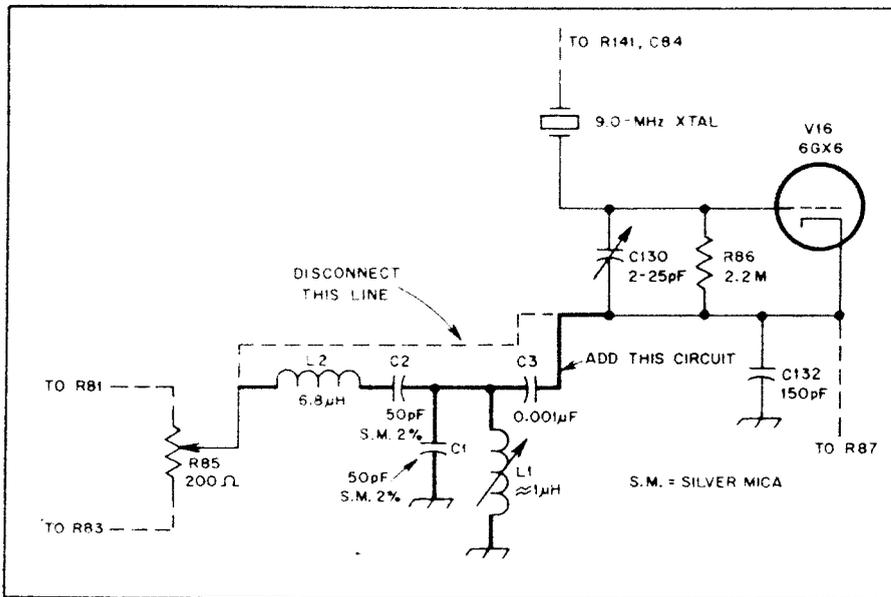
Fig. 1 — This filter circuit is designed to eliminate TVI from Drake TR-4 transceivers. The heavy lines show circuit changes. With the aid of a loosely coupled dip meter placed near L1, tune L1 to resonate at 9.0 MHz. Tuning is not critical.

peared on TV channel 2 when my TR-4 was operating on 14 MHz and on channel 4 when the transceiver was on 21 MHz. Use of a low-pass filter at the output of the transmitter and high-pass filters on the TV sets partially eliminated the TVI. Further steps had to be taken for a complete cure.

Cause: Strong radiation on the 2nd, 3rd and 4th harmonics was noted. A low-pass filter effectively reduced interference received via the transmitting antenna. With the help of a search loop and spectrum analyzer, I established that undesirable harmonic radiation was coming from the chassis. Further investigation disclosed the presence of relatively strong harmonics at the grids of the 6JB6 final amplifiers. These unwanted signals passed right through [for perhaps *around* — Ed.] the 9.0-MHz sideband crystal filter. Correcting this condition and eliminating harmonic content in the final amplifier by adjusting the amplifier for proper linearity brought the matter to a successful conclusion.

Cure: Oscillator distortion was corrected by installing a 9.0-MHz parallel-resonant circuit (Fig. 1) from the wiper of the carrier balance potentiometer to the cathode circuit of V16. This circuit is tuned to approximately 9.0 MHz with the aid of a dip oscillator. Final adjustment is

accomplished by observing an oscilloscope connected to the grids of the 6JB6 amplifiers while tuning for maximum amplitude. The transmit-gain potentiometer should be set in the linear region (about the nine o'clock position) for this adjustment. Realignment of the 9.0-MHz oscillator according to instructions in the Drake manual is also required.

Linearizing the final amplifiers is done simply by providing for additional cathode degeneration. To do this merely remove the 470-pF capacitors from pin 3 of the 6JB6 amplifiers. The power reduction is not noticeable.
