Modification of Tone Control in the Drake R8

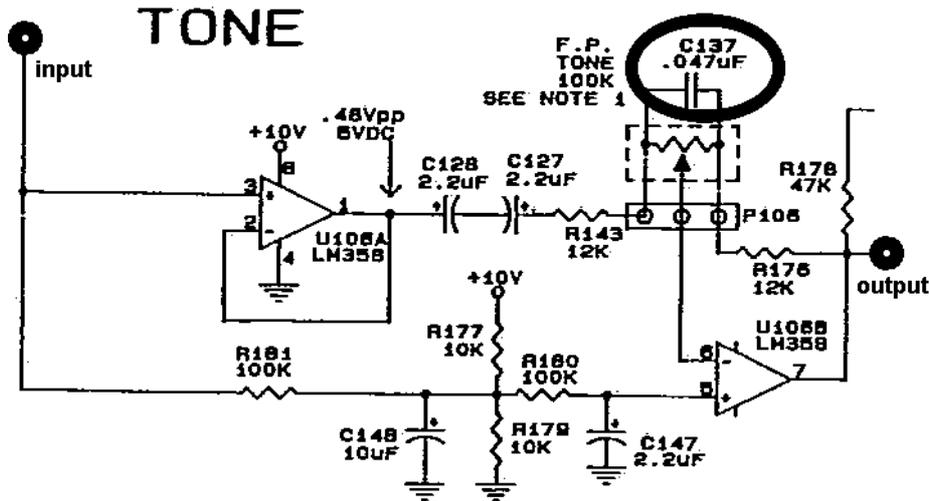
The tone control in the R8 isn't very effective. The circuit description /1/ specifies a boost of +/- 10dB for the bass response. A simulation with 5spice /2/ of the circuit (picture 1) shows this +/- 10dB variation only at 100Hz and lower frequencies, higher frequencies have a much smaller variation.

Picture 1 Tone Control circuit in the R8

Analysing the circuit, C137 (47nF) is found as the determinant component in the tone control (pictures 1 and 2). In the simulation (picture 3), „cw“, „center“ and „ccw“ are the positions of the tone control pot at the R8's front.

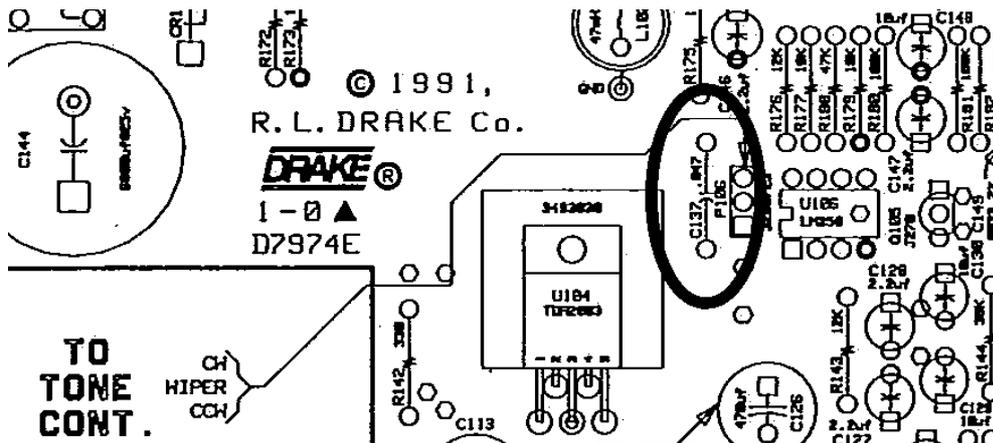
Picture 2 Second IF Board Layout

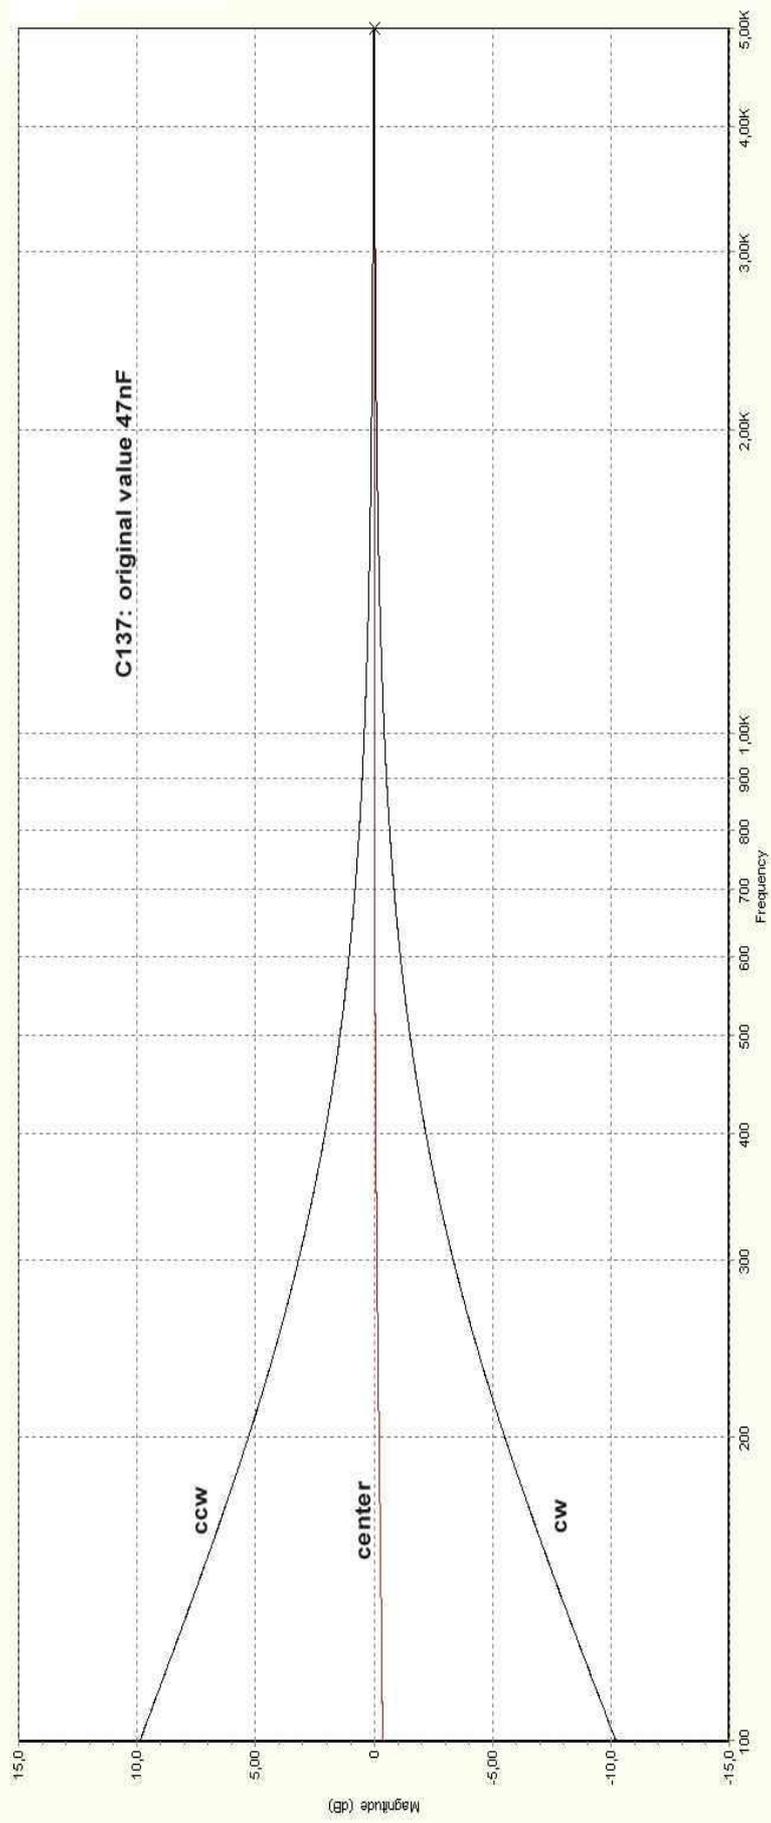
Picture 3 Simulation of Tone Control (original circuit)

The comparison of pictures 3 and 4 (same scaling) show the positive result: At 100Hz, the boost and cut is now +/-15dB instead of +/-10dB in the original circuit.

Note 1: A further reduction of C137 is possible; e.g. down to 15nF or 18nF, but this will affect not only the basses. In picture 4 the boost of 1kHz is app. +/-1,5dB, whereas in the original circuit (picture 3) the 1kHz-boost is only app. +/-0,5dB. That means, a further reduction of C137 leads not only to a boost of the basses but also to a boost of higher frequencies – there is no further win. A simple R-C-circuit can't be a very good tone control; it's always a compromise and not an equaliser.

Note 2: The small drop in the „center“ position (red curve) and the small unbalance at „cw“ and „ccw“ at low frequencies in pictures 3 and 4 are caused by the series capacitors C127 and C128.

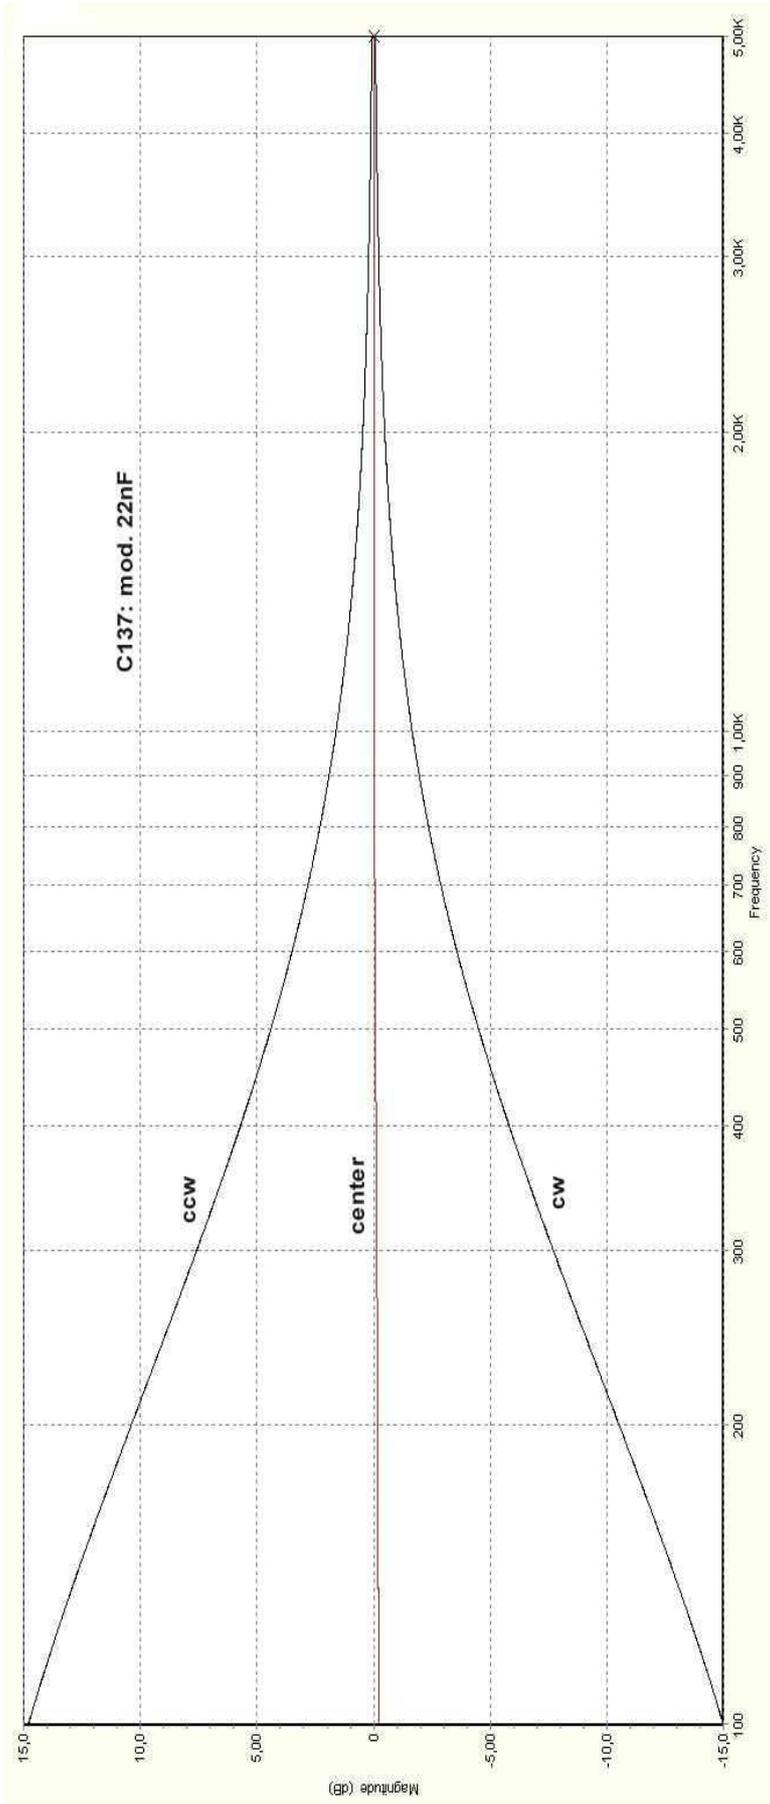
Decreasing the value of C137 from 47nF to 22nF increases the possible variation in the bass response. The simulated result is shown in picture 4.

Picture 4 Simulation of Tone Control (modified circuit)

In the „center“ position of the tone pot, the frequency response is linear over the whole range (see note 2).

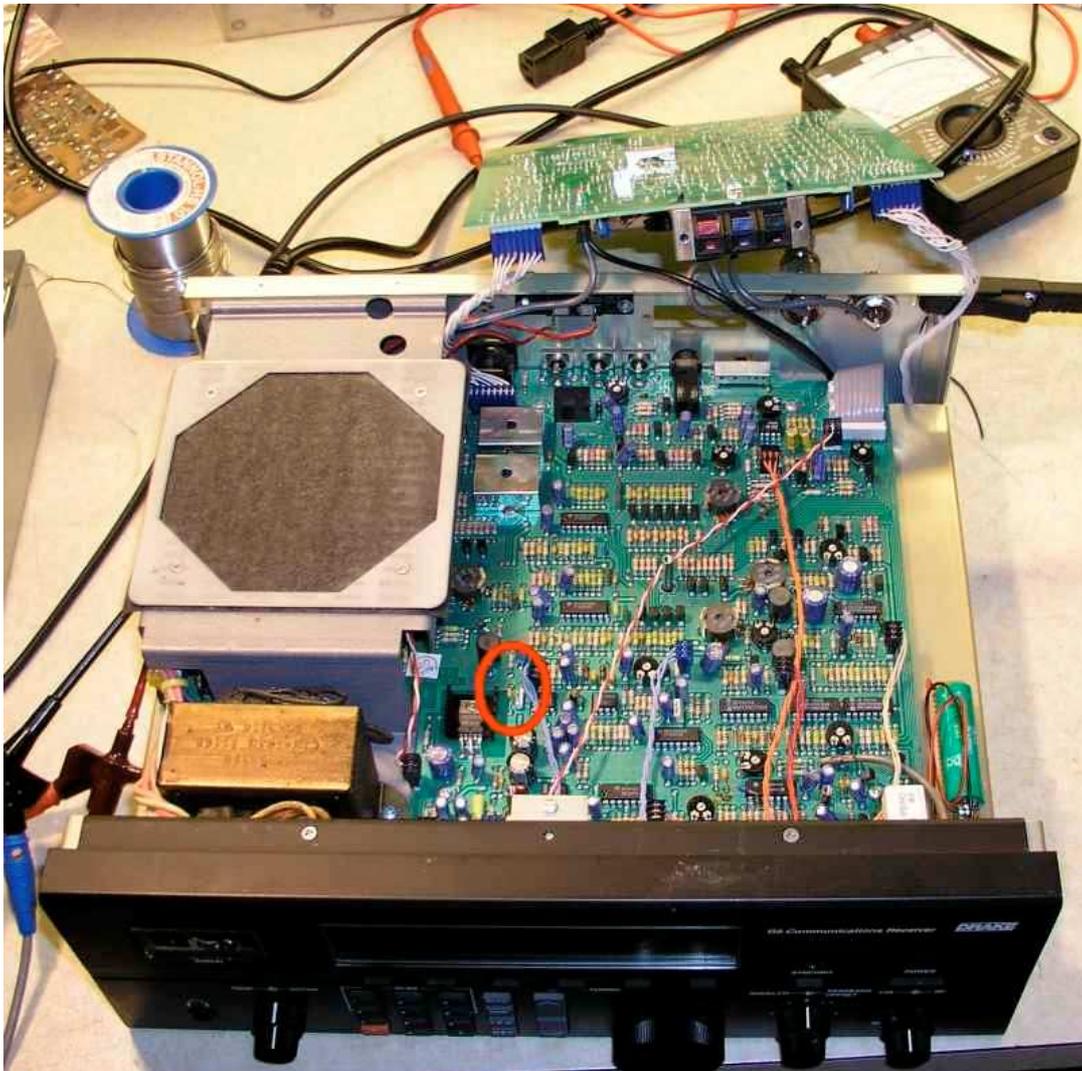
Picture 5 Location of C137 (front end board removed)

It is necessary to remove the front end board (4 screws and 2 screws at the back side) and bend it away (picture 5). Unplugging the front end board is not necessary, all cables are long enough.

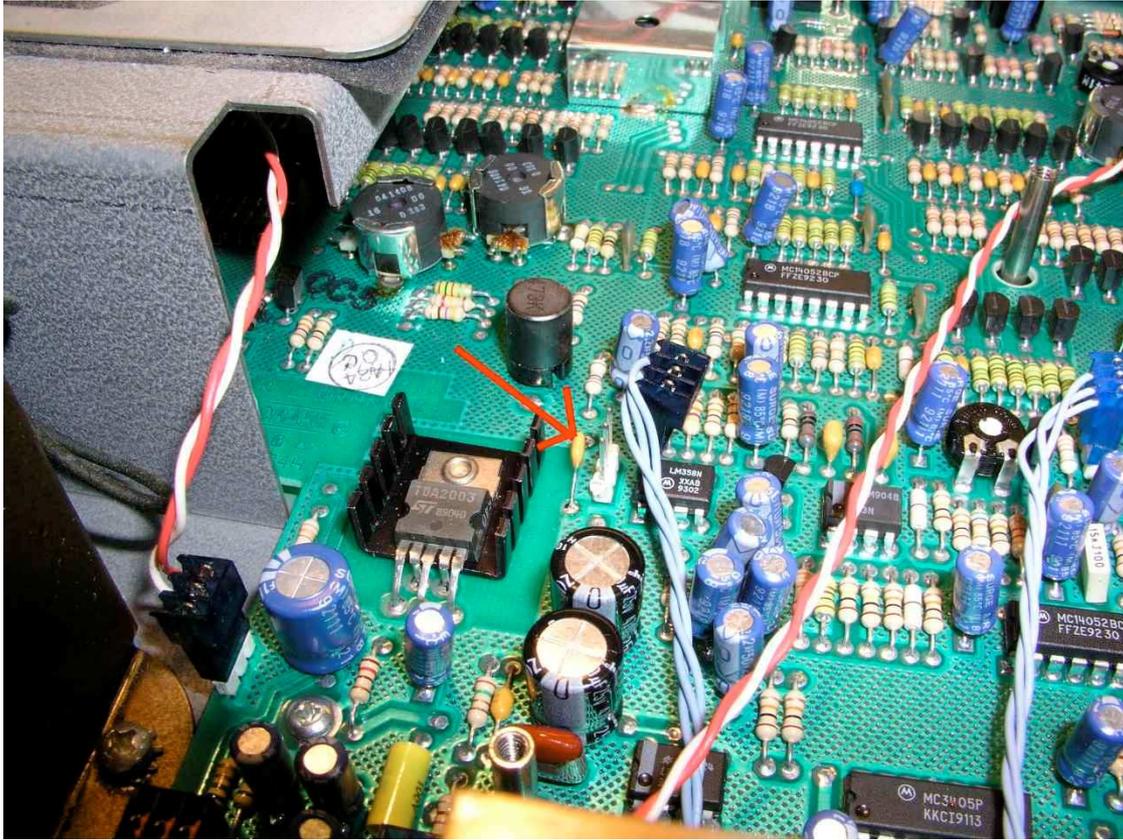
Picture 6 C137, plug P106 removed

Now, C137 can be replaced without removing the 2nd IF/Audio/power board (picture 6). Use a solder sucker to clean the pads and then solder the new C137.
