# Heathkit Troubleshooting Tips

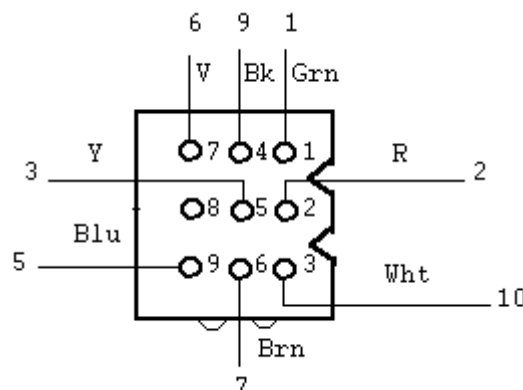
- **No scroll:** Check for interchanged blue and green wires to S503-5 and -6 beneath the picture tube. Green should go to S503-5.
- **P603 pin-out (rear view):**

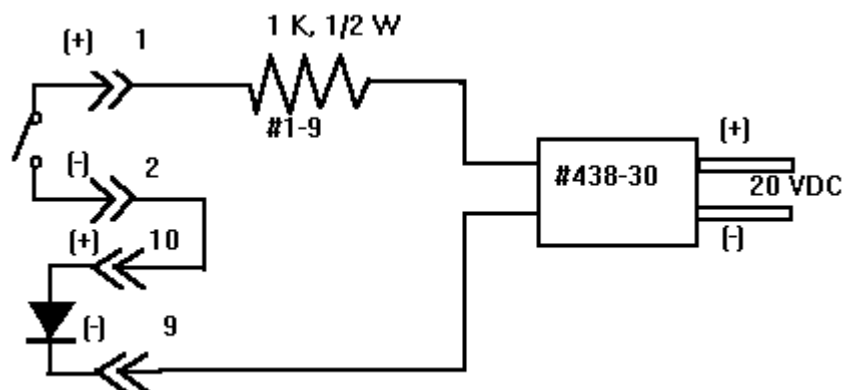
- **20 mA current loop (passive):**

- I'm not sure how I used the above circuit to test the H9 20 mA passive current loop function. Apparently, I plugged the dual banana connector into a 20 VDC power supply and did something with the switch. The

switch may represent a keyboard key and pressing it would echo the character back to the screen. (ww 6 July 1996)
